## ANNUAL EXPERIMENTAL EVALUATION REPORT

### Cold In-Place Recycle (CIR) Koch™ Process CIR-EE

Location: Red Lodge, Montana – Carbon County, Highway 212 (P-28) Milepost 91-101.6

Project No.: Red Lodge North STPP 28-2(22)70

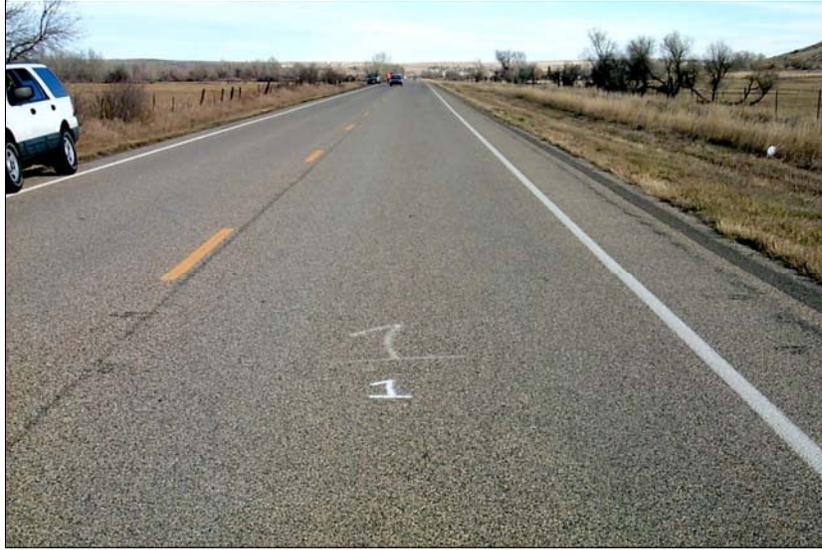
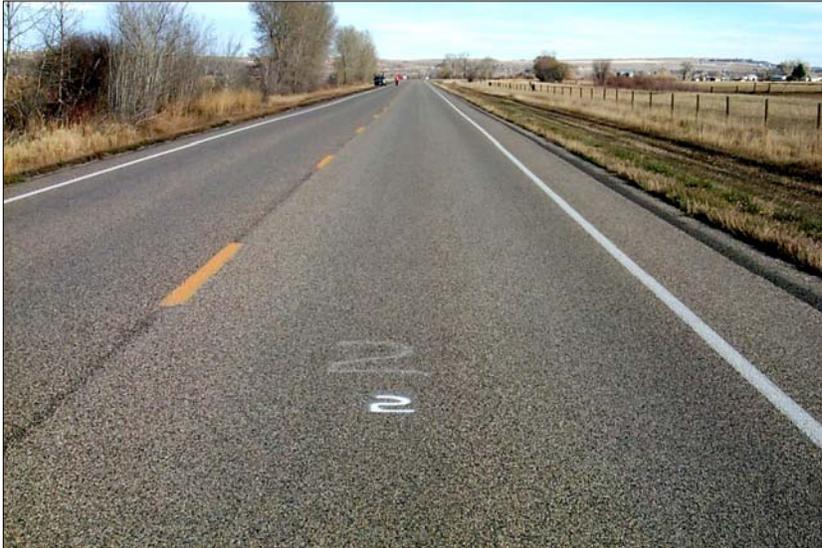
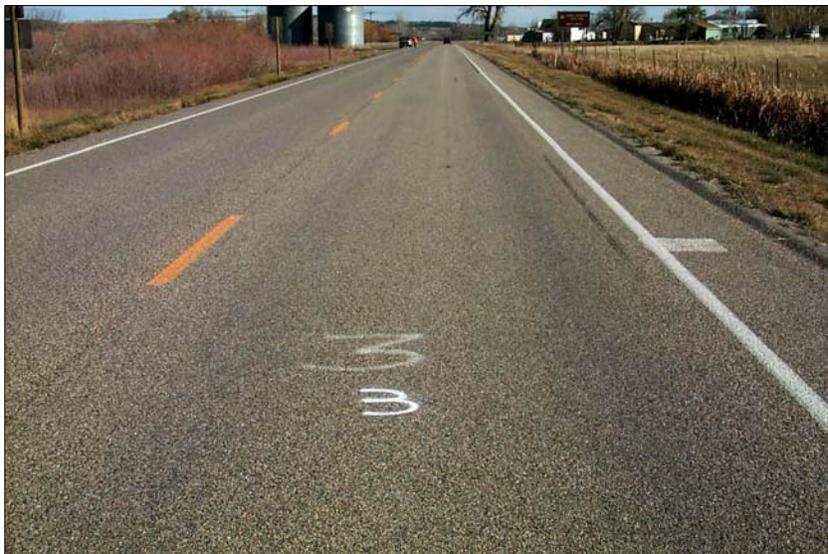
**Section 1: MP 89- MP 91, 90mm cold mill, 105mm PMS**

To date sections 1, 2, and 6 have no noticeable cracking. Sections 3 & 4 are beginning to show progressive transverse cracking, all low severity in nature. At this time the extent of transverse cracking in all sections is minimum and rated as good to fair.

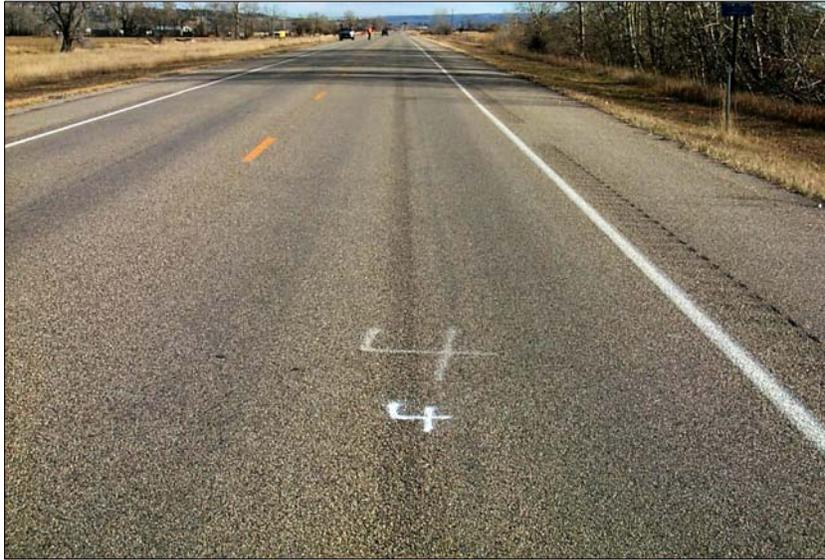
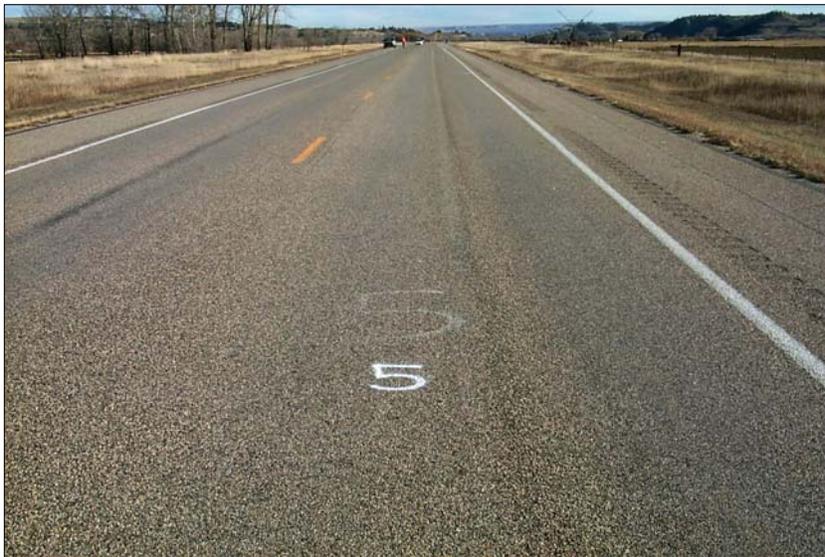
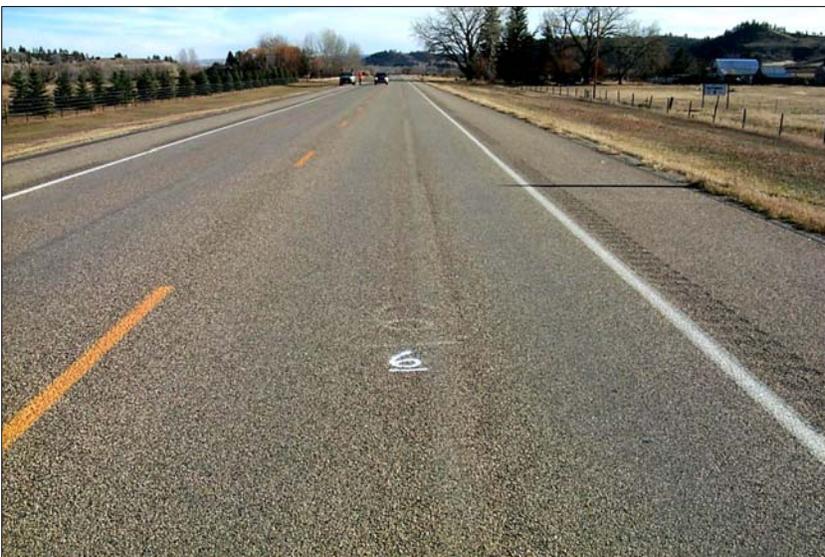
**Section 2:** MP 91-MP 94.3, 75mm recycle with 45mm PMS overlay

Most data sites exhibited good appearance and even seal with minimum rut. Several sections did have minimum flushing mainly in the wheelpaths. Section 2 (75mm recycle, 45mm PMS) displayed the best performance in rutting. Both 75mm recycle sections (3 & 5) exhibited the most in averaged increased rut. On average rutting is minor on the entire project.

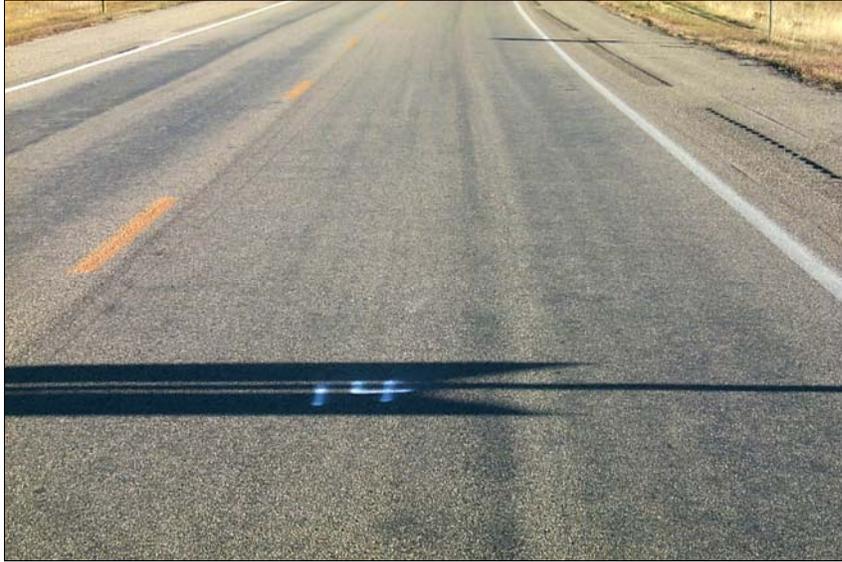
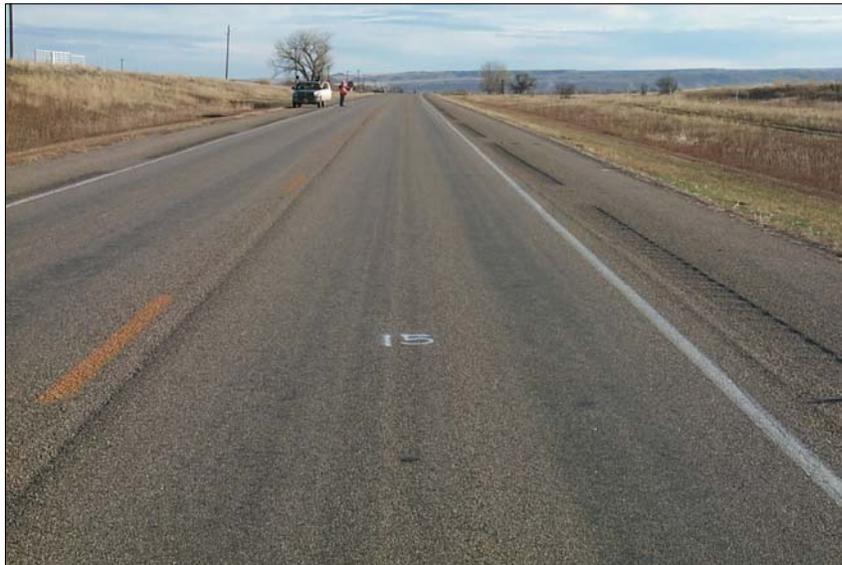
**Section 5: MP 96.3-MP 98, 75mm recycle with seal and cover**

\*This data site was located in section 5, milepost 97.5 at the 75mm recycle site. The extrapolation puts the CPM at 68, with a standard deviation of 2.0. This report will note that initially with the first annual inspection there was an abnormally high transverse cracking within the 300' data site. To date, four, low severity across-lane cracks and one partial lane crack were documented. The other two data sites within this section are just beginning to exhibit across-lane cracking. In earlier analysis it was speculated data site 97.5 was anomalous with cracking compared to the entire section. The new cracking within the section data sites may be an indicator of performance.
